I just connected my end nodes (typically a switch and a router) to an optical tap. The end nodes are successfully communicating but when I make a logical connection, map or pass-all in the GigaVUE, no frames are coming out of the tool ports. Why is that happening?

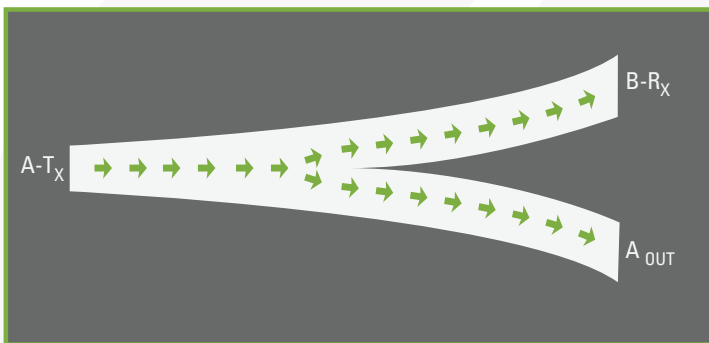
Diagram A

In **Diagram A**, the switch and router Tx and Rx fibers are connected correctly. The end nodes both see light passed through successfully to each other. The light is travelling in the **same** direction as the splitter, so a percentage of the light is successfully split off and sent into the GigaVUE.

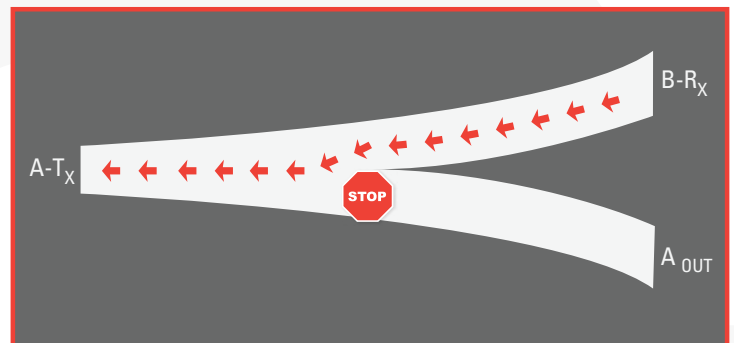
Diagram B

**Answer:** The most common reason for this symptom is that the transmit (Tx) and receive (Rx) fibers are reversed on both the switch and router. If this is the case the **show port-params** command will indicate extremely low or no light coming into the interface. The **show-port-stats** command may also indicate IfInErrors are occurring. You should execute those commands to verify this is the case. To understand why this is happening look at the diagrams below.

In **Diagram B**, the switch and router Tx and RX fibers are connected incorrectly. The end nodes both see light passed through successfully to each other. The light is travelling in the **opposite** direction as the splitter, so very little or none of the light is successfully split off and sent into the GigaVUE.

The solution is to reverse the physical connections of the Tx and Rx leads on both the end nodes.
